Shenandoah County Sustainable Farm Demonstration Progress Report March 2018

By Robert A. Clark
Senior Extension Agent, ANR, Crop & Soil Sciences

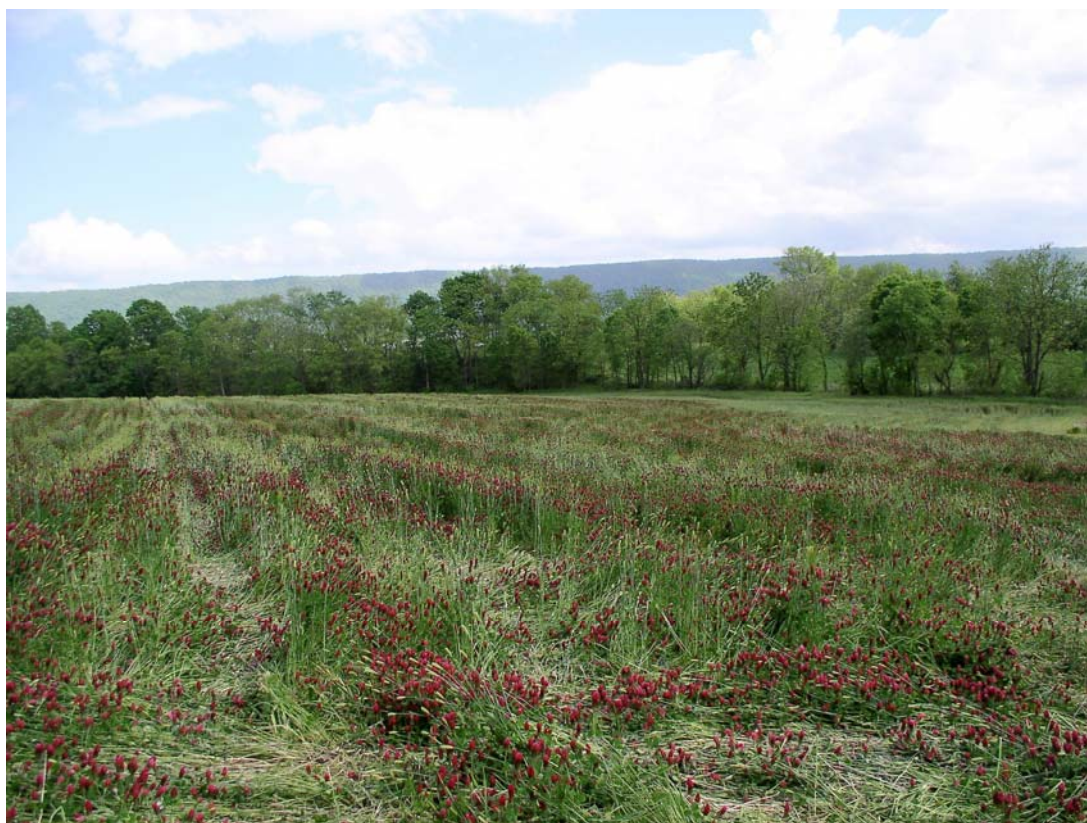
A mix of Small Grain and Crimson Clover planted as cover crop on the County Farm.

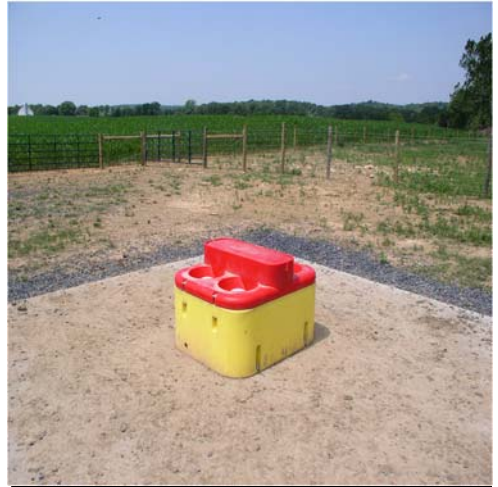
A water trough installed to provide water to livestock in lieu of using the pond or small stream.

All fencing and a watering system have been installed for both the managed grazing demonstration and the demonstration of reclaiming the overgrown pasture. This includes over 10,000 feet of fence and 2,000 feet of pipeline. Funding for this effort was a collaborative venture between Shenandoah County, the farmer leasing the land, and the Lord Fairfax Soil and Water Conservation District.

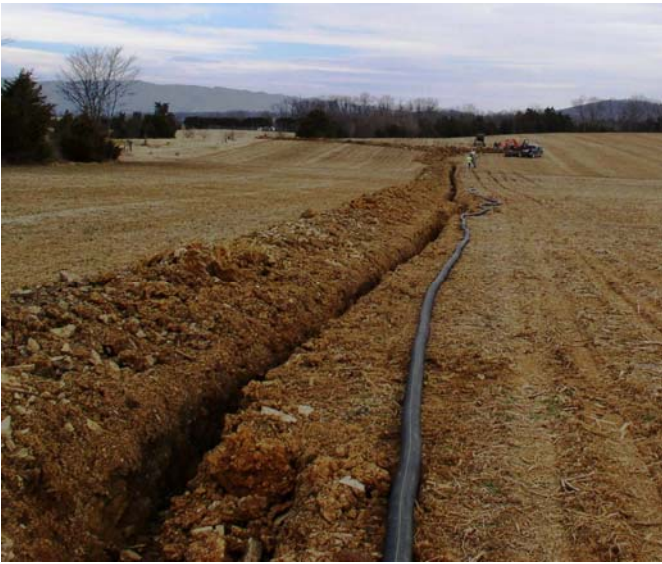
Installing a water line to supply water for livestock.

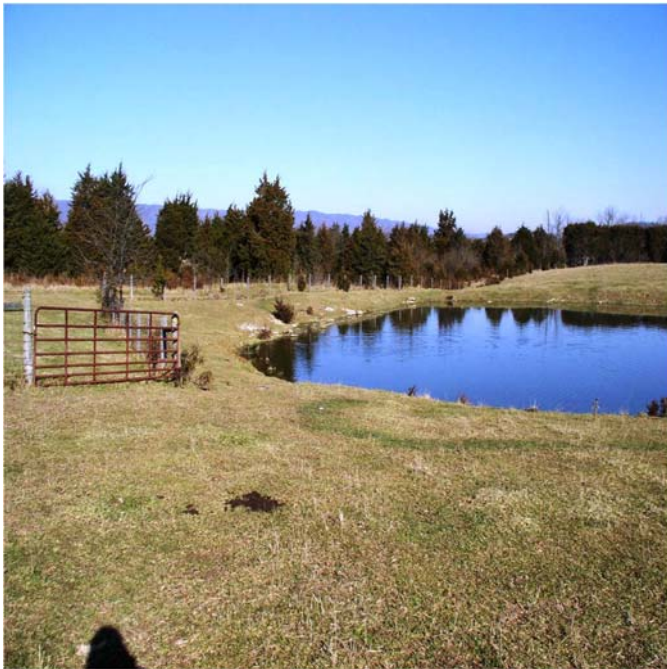
Picture Above Left: The pond on the Shenandoah County Farm prior to livestock exclusion.

Livestock were excluded from a pond and a small stream. The pond and a small portion of the pasture were subsequently allocated to the County Park. They have expanded the Disc Golf Course from a nine-hole course to an 18-hole course. The pond and surrounding area is also open to light recreation.

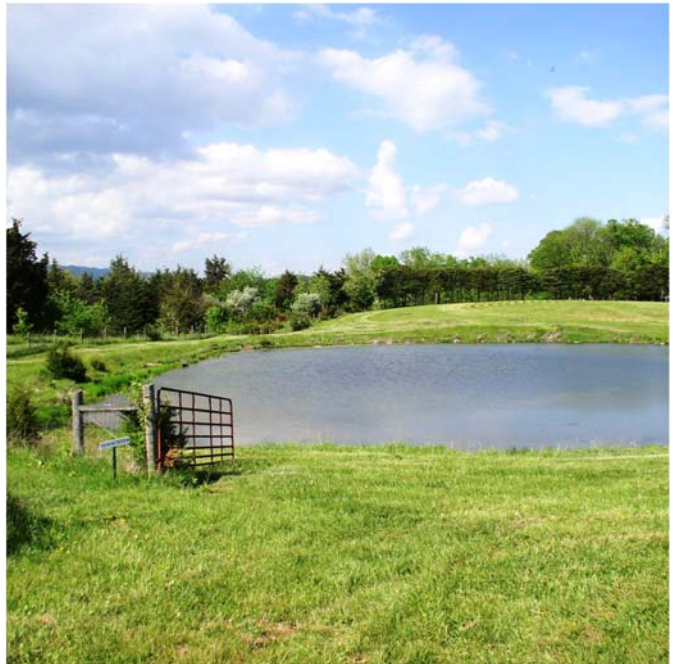
Picture Above Right: Pond and a portion of farmland adjacent to the pond was made available to the County Park. It is being used for disc golf and other light recreation.

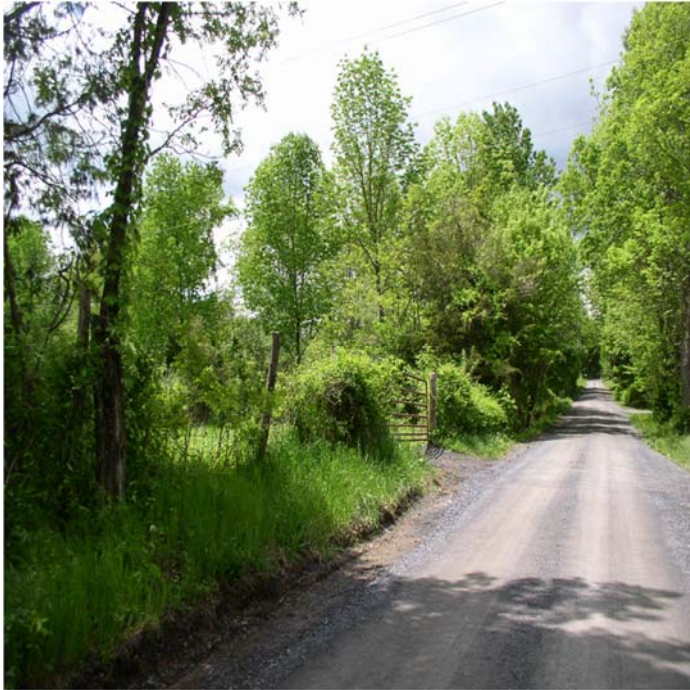
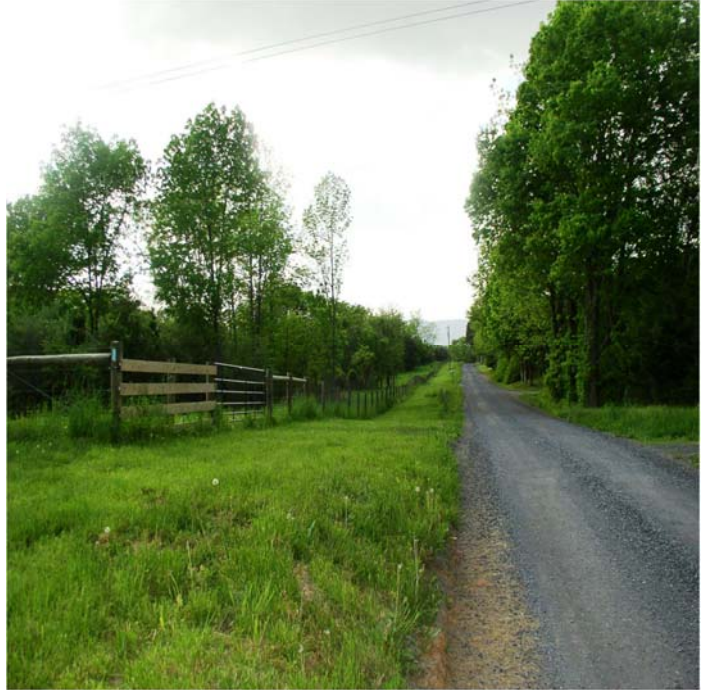
Picture Top Left and Right: Fence along Teaberry Road prior to fence construction (Left) and after new fence construction (Right). Note the blue paint on the nearest post marking the Tuscarora Trail.

Shenandoah County paid for the construction of a new fence along a public road that adjoins the County Farm. This fence is part of the pasture system on the County Farm. This fence had become highly overgrown. Removing the fence and excess growth improved road safety and it improved the view of the County Farm. Also, the fence was set back from the road by 15 feet to allow better access to the park for the Tuscarora Trail.

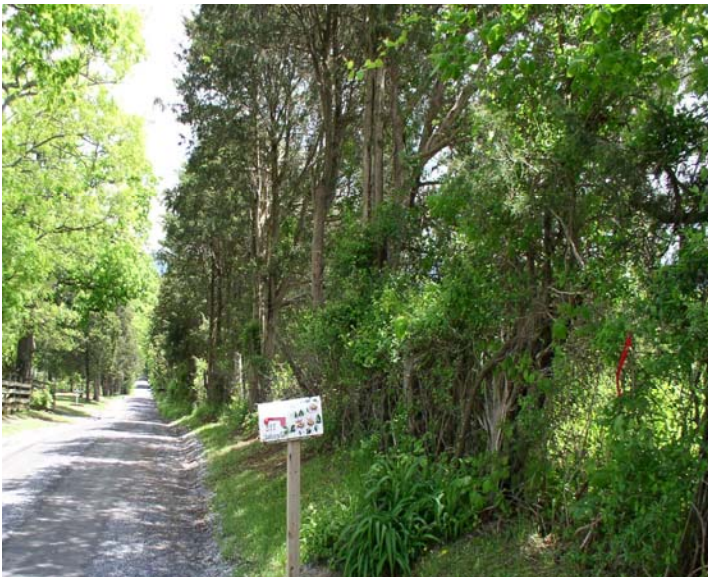
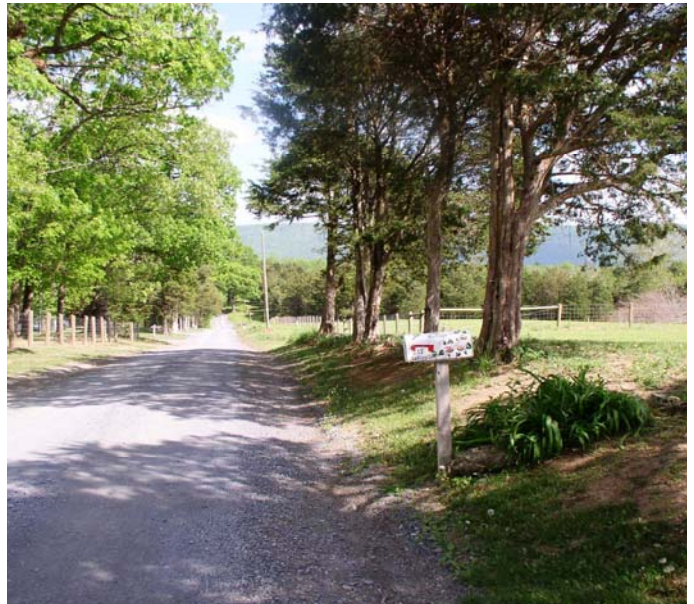
Picture Bottom Left and Right: The County Farm is the site of The Battle of Toms Brook in the Civil War. Removing the overgrown fence along Teaberry Road allows visitors to view the County Farm.

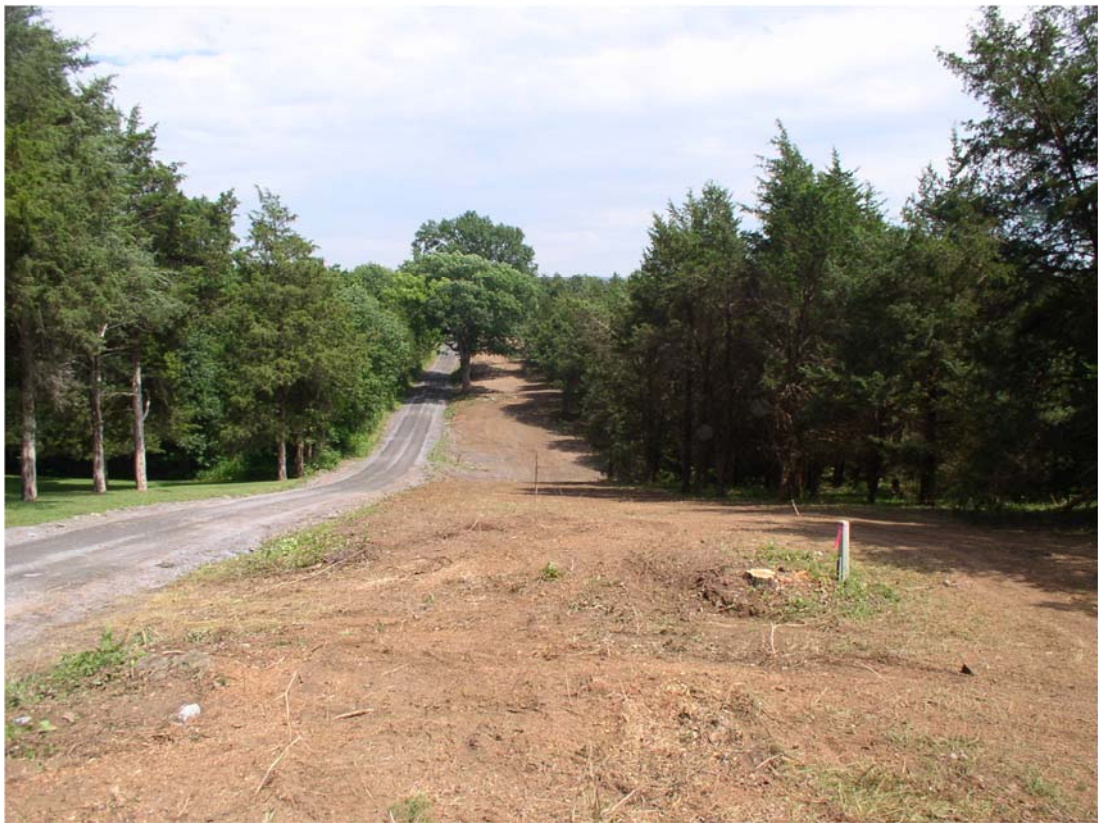
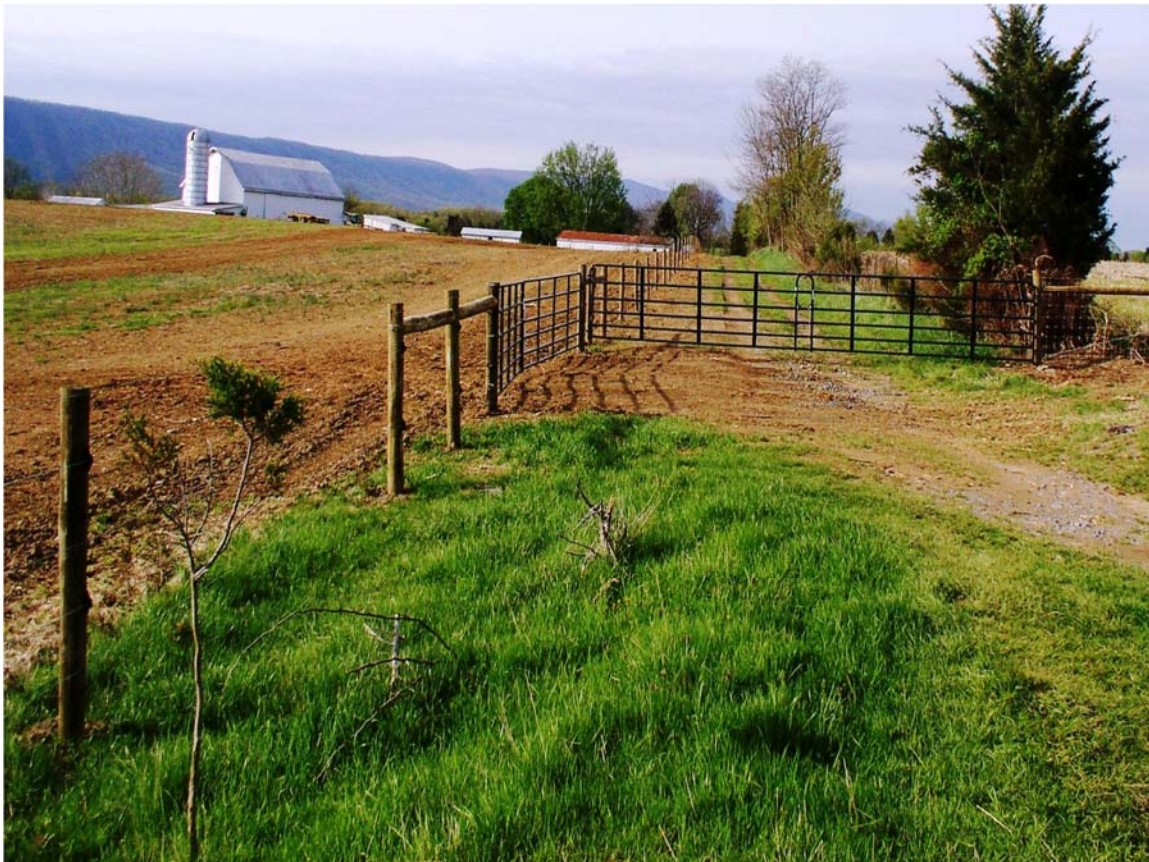
Clearing trees and
fence construction
along
Teaberry Road.

There were two
miles of interior
fence constructed
on the
County Farm.

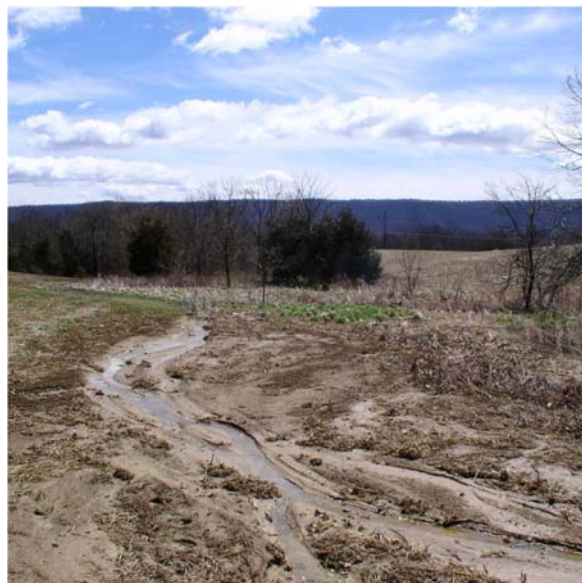
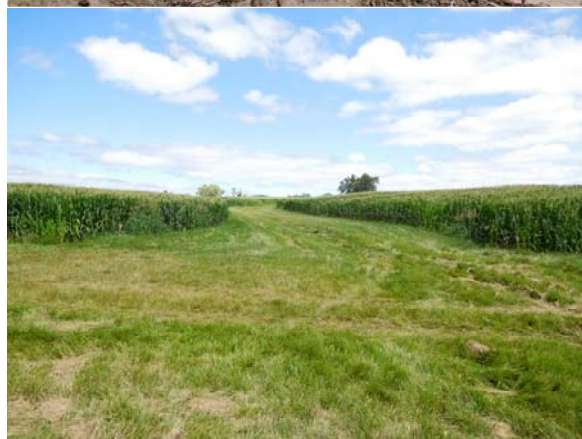
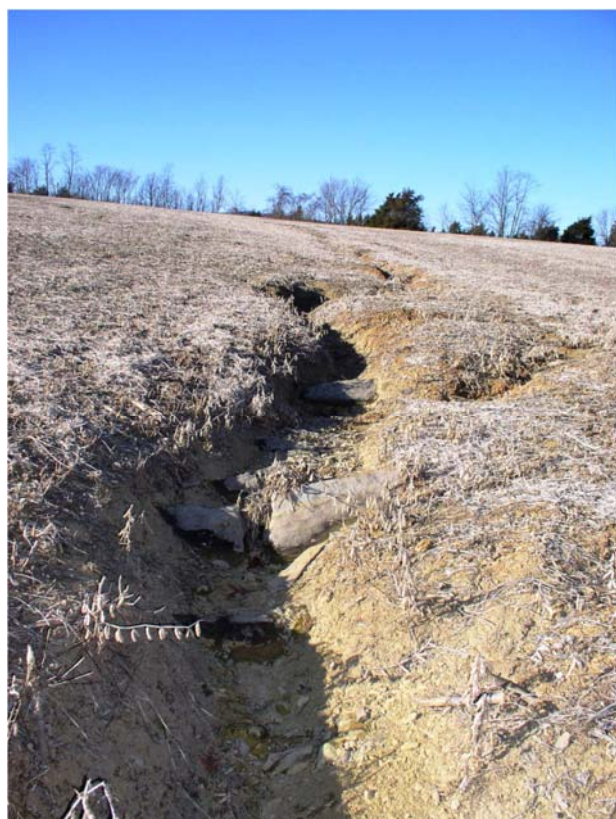
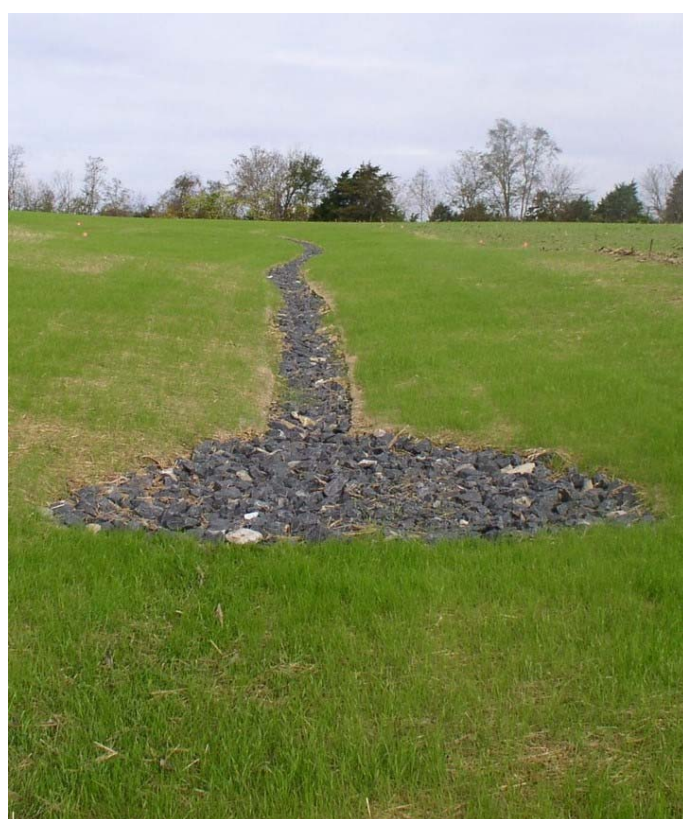
Pictures to the Right and Below:
Before and after images of grassed waterways
that were created on the County Farm.

Grassed waterways are installed on farmland to prevent soil erosion in areas where surface runoff is inevitable. Approximately 2.8 acres of grassed waterways have been installed to date. An additional two acres will be installed in the future. The waterways are designed to allow surface water to exit the field without causing erosion. Also, the grass will filter sediment and nutrients that may run off of the cropland.

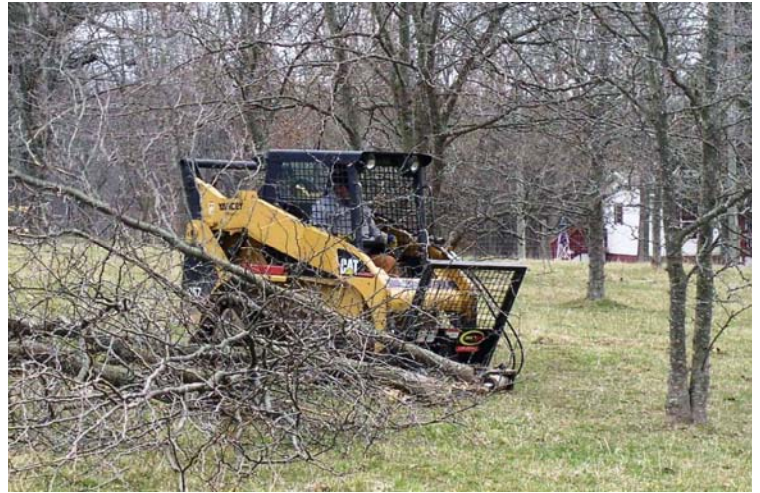
This machine, equipped with a shear (hydraulic scissors) was used to remove about 140 Honey Locust from the County Farm.

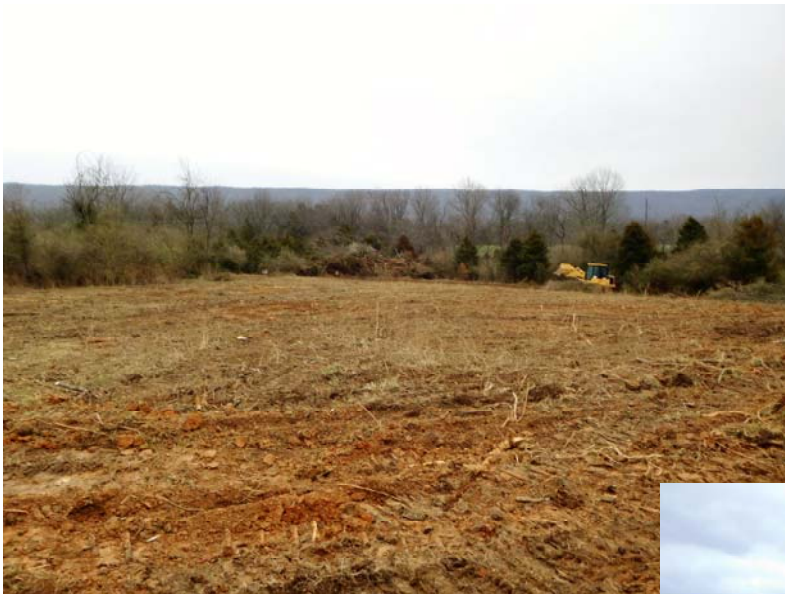
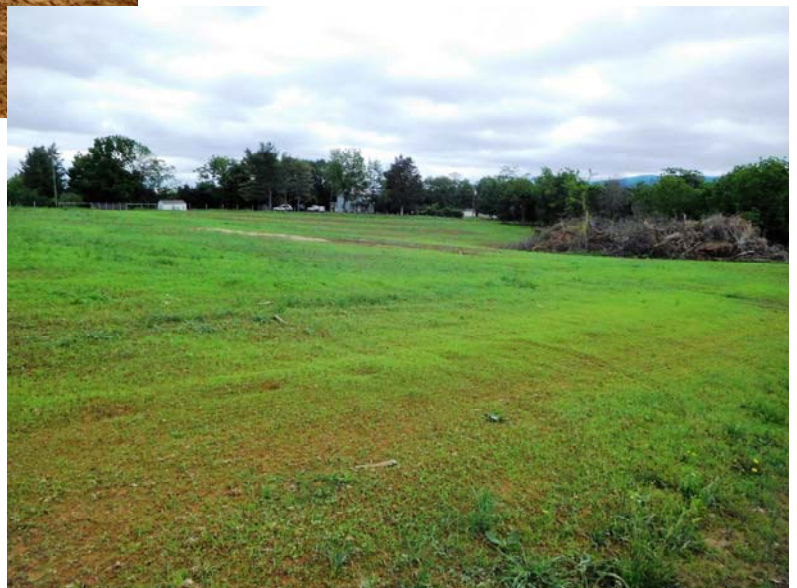
Above Picture and Picture to Right:
Clearing overgrown pasture on the County Farm
and new grass established.

Three different techniques have been used to remove some of the brush and invasive species. The costs of each has been documented. We conducted one educational meeting about brush control. Landowners and farmers will be able to visit the farm in the future so they can choose the method that is most appropriate for their farm.

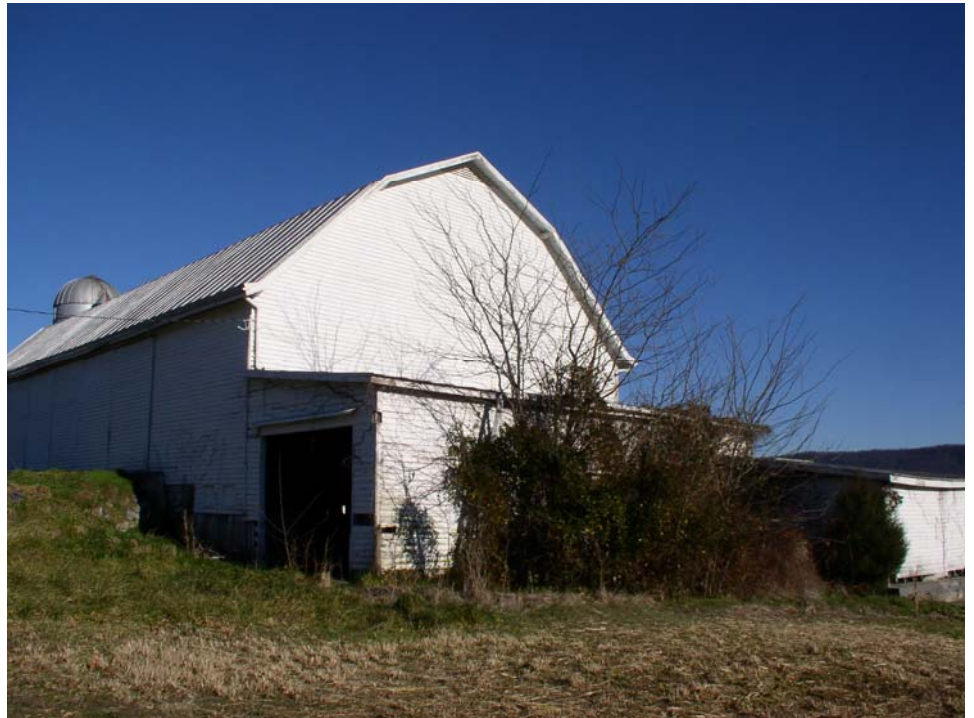
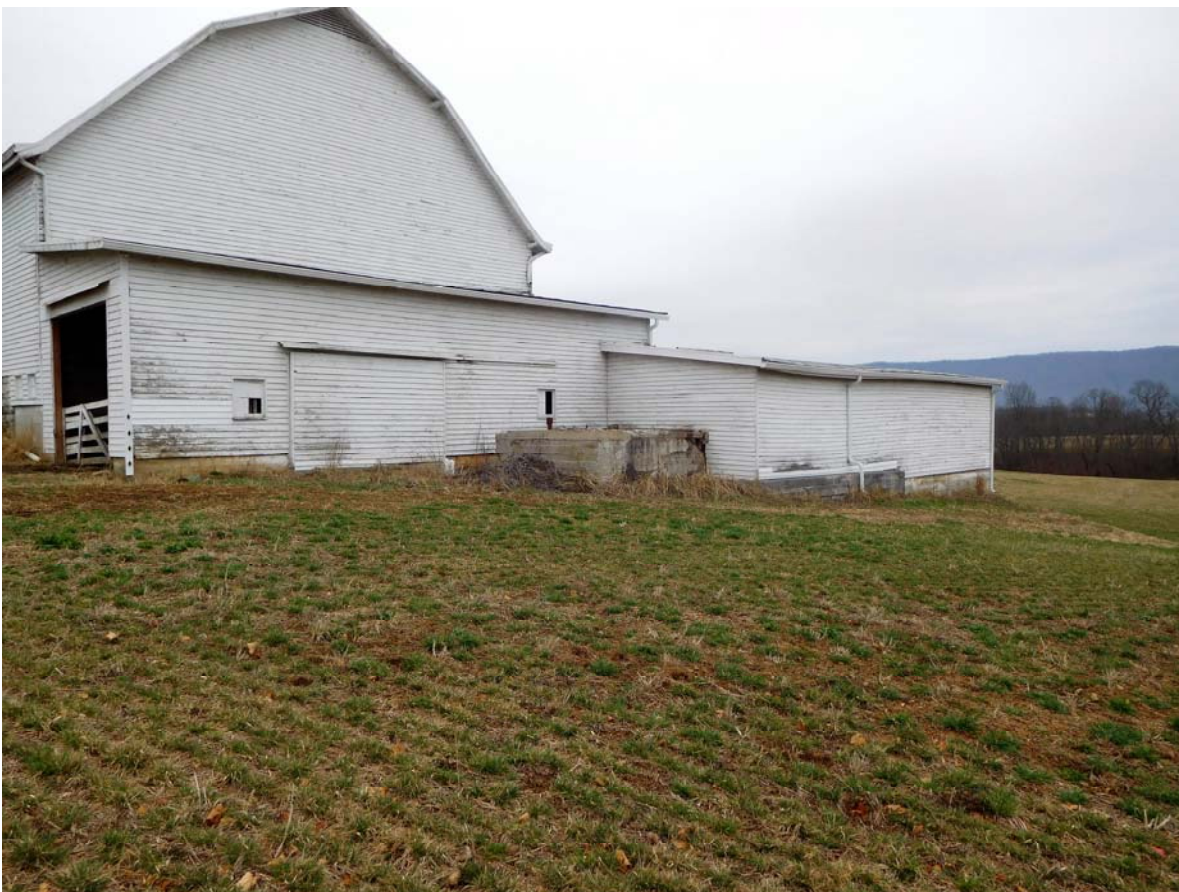
Picture to the right shows the barn prior to removing brush and reinstalling guttering. The picture below shows the barn after completing the maintenance.

The barn, machinery shed, and pump house are an integral part of vibrant agriculture on the County Farm. In 2016 and 2017, significant effort was made to remove brush from around the buildings, replace guttering, and repair some of the siding.
